Brickhouse FL6 Series Product Test Report

TEST DATE: February 26, 2010

TEST PRODUCT: FL6-12SP1 Counterweight Arbor

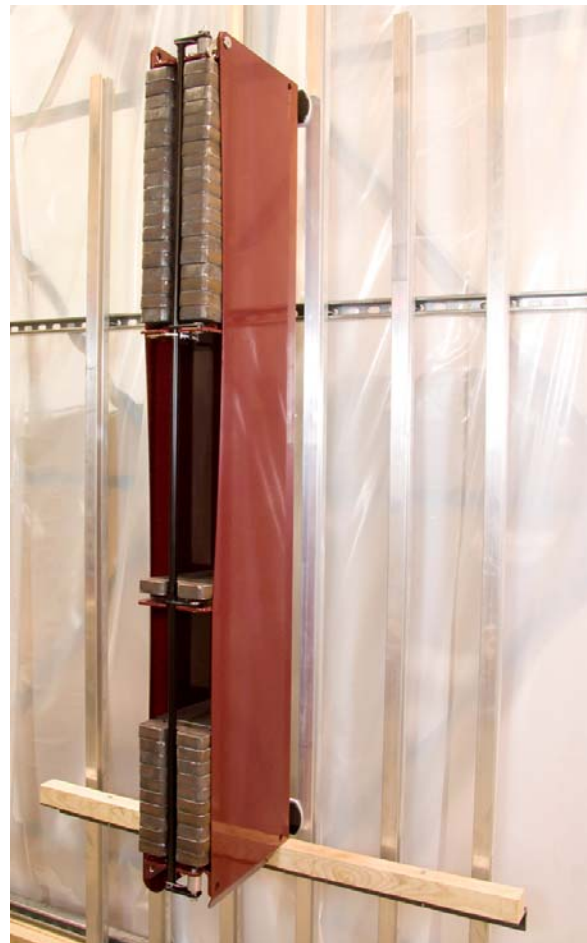
Arbor setup prior to test.

1. For testing purposes, the arbor is loaded to a total weight of 750 lb but not rigged to lift a load. Approximate speed of the falling arbor is 23 feet per second resulting in an approximate kinetic energy of 6,300 ft lb at impact. This energy is roughly equivalent to the amount resulting from a typical 40 ft system with a 250 lb weight imbalance between the arbor and the load.

2. Construct an arbor guide wall typical of theatre counterweight systems utilizing aluminum T-bar sections on standard 8 inch centerline spacing.
3. The lower bump stop (first point of arbor contact) should be standard 2x3x3/16" angle with 2x2 hardwood rail. Attach the bump stop angle with 5/16" fasteners to six aluminum T-bar sections.

4. The FL6-12 Series arbor has 3 counterweight compartments. Load the top compartment completely full of Brickhouse style steel counterweight bricks (412 lb). This will put maximum stress on shelf welds and side plates.

5. Load the center shelf with a single brick (22 lb). This will allow maximum potential movement of the brick.
6. Load the bottom shelf about half full (217 lb). This will provide an intermediate compartment-loading scenario.

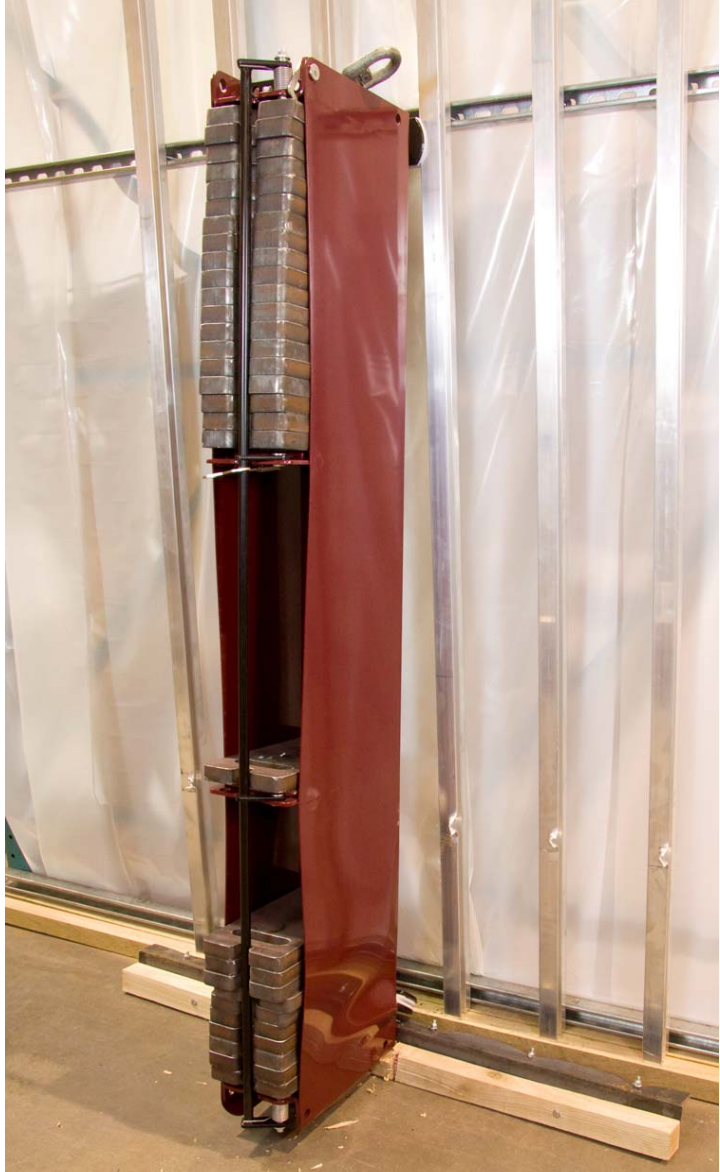
Test #1 – Arbor post drop test.

Test Result: The bump stop rail mounting bolts pulled cleanly through the aluminum T-bars. The force of the bricks on the gate was sufficient to shear the pivot screw holding the gate latch. The force was not, however, enough to permanently deform the gate. Permanent deformation to the main arbor weldment occurred at the bottom due to contact with the ground. Deformation occurred at the sides of the arbor enclosure. The energy from the top stack of weights caused the sides to bow outward below that compartment. There was no indication of structural damage at any of the principle welds (top, bottom or shelves).

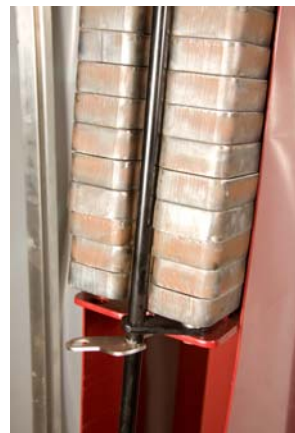
Test #1 – Top shelf weight movement post test.

Test Result: As the arbor continued towards the floor and final impact, the brick weights slid forward making contact with the gate. The weights moved forward only enough to engage with the gate, which prevented further movement. Weights had to be pushed back in place in order to open the gate.

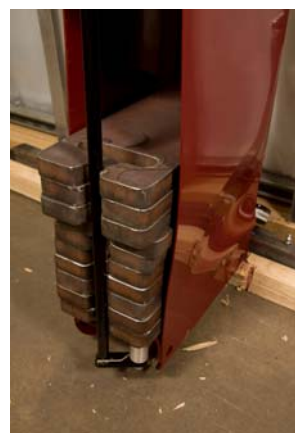
Test #1 – Bottom shelf weight movement and deformation post test.

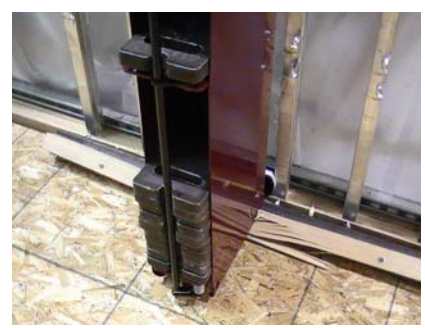
Test #2 – Bottom shelf weight movement post test.
